HISTORIC STRUCTURE REPORT:  
THE CUSTOM HOUSE AND TOWER

VOLUME II:  
EXISTING CONDITIONS AND RECOMMENDATIONS

SARA B. CHASE  
and  
ANNE A. GRADY

SOCIETY FOR THE PRESERVATION OF  
NEW ENGLAND ANTIQUITIES  
CONSERVATION CENTER

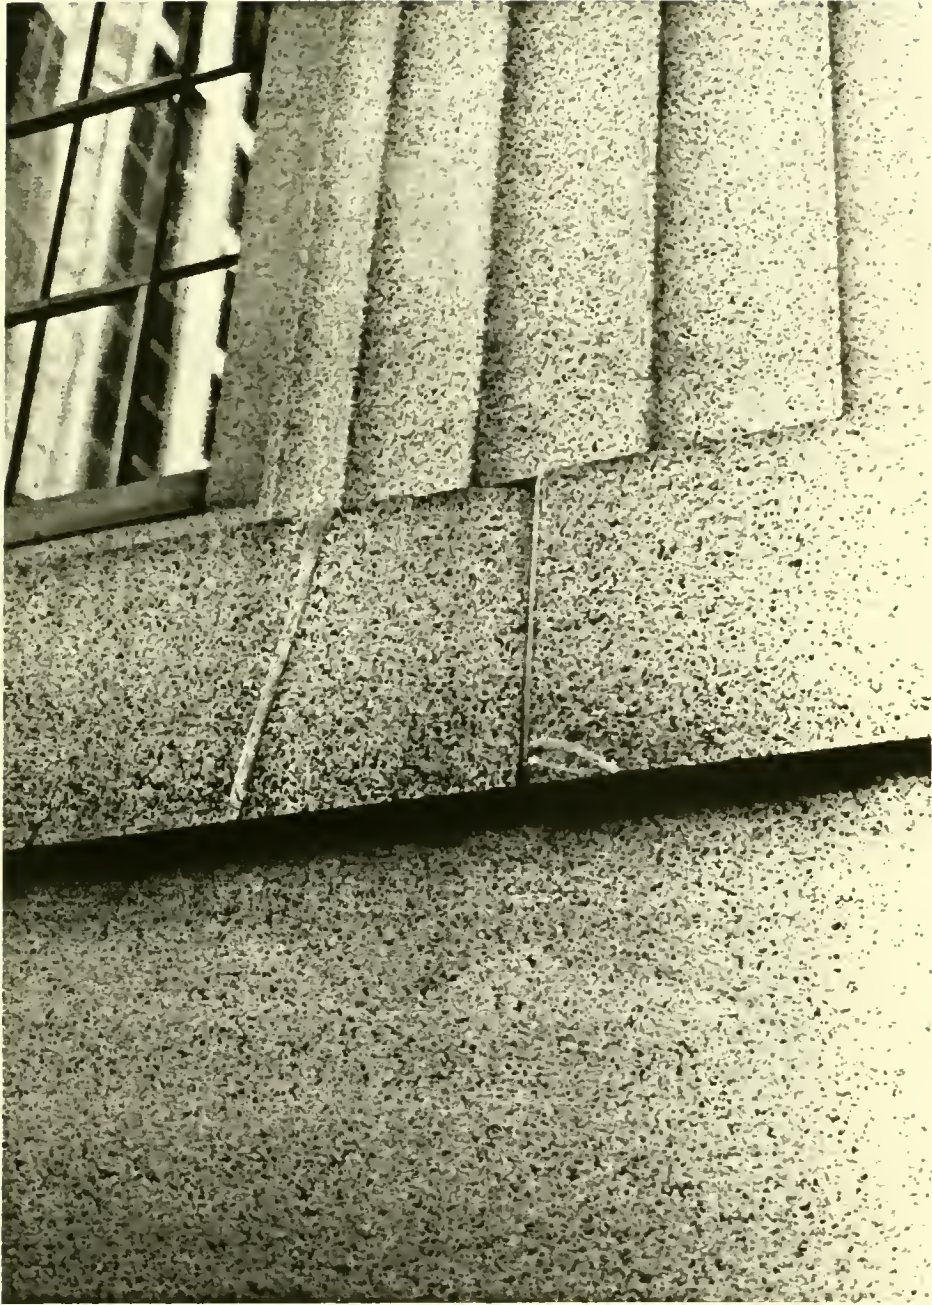
Figure 1

View of typical caulking in old crack

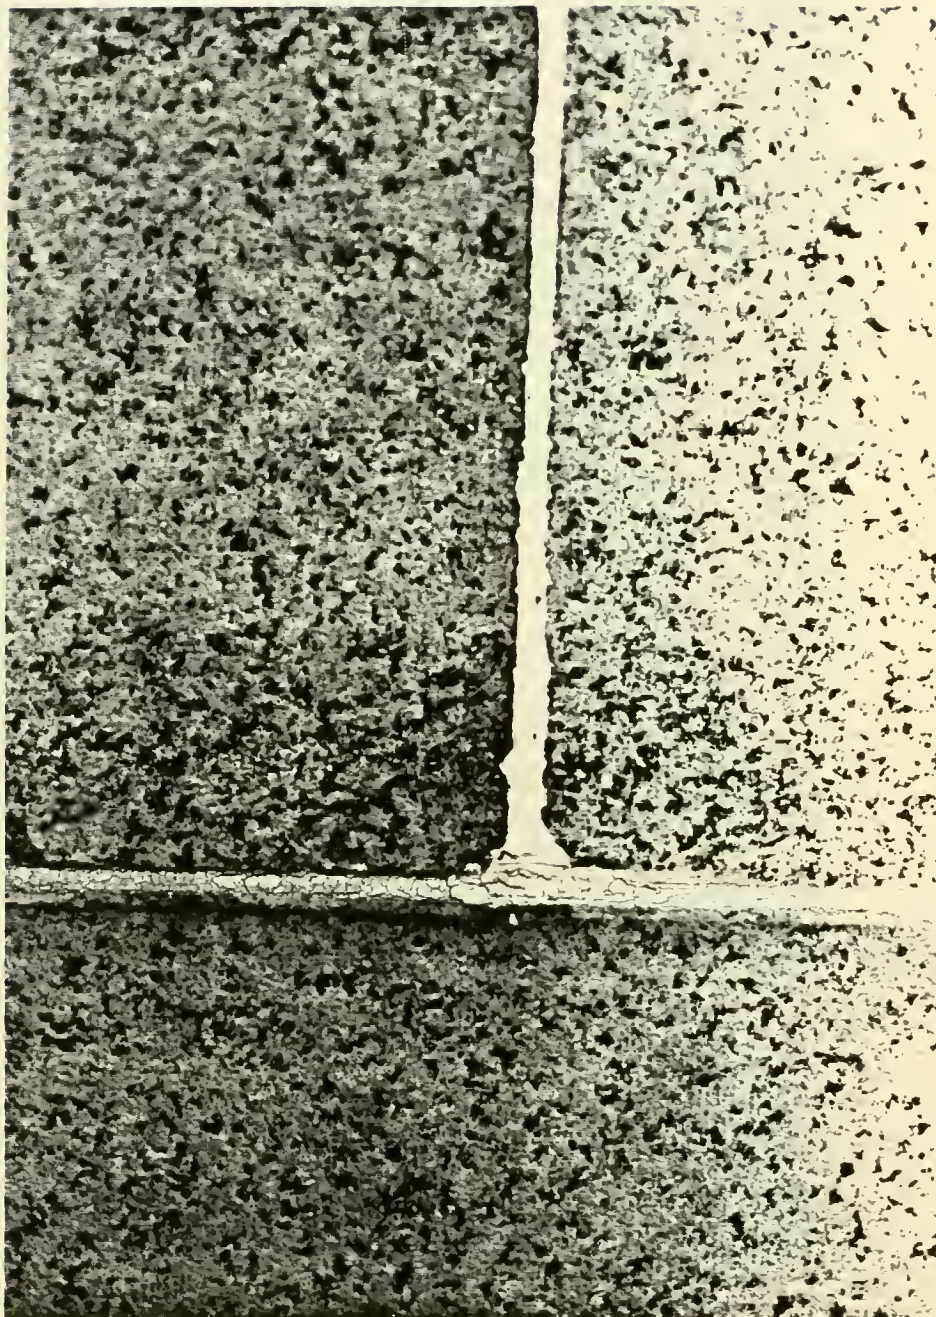
Figure 2

View of typical conditions of old 1970 caulk  
and newer caulk in stone joints

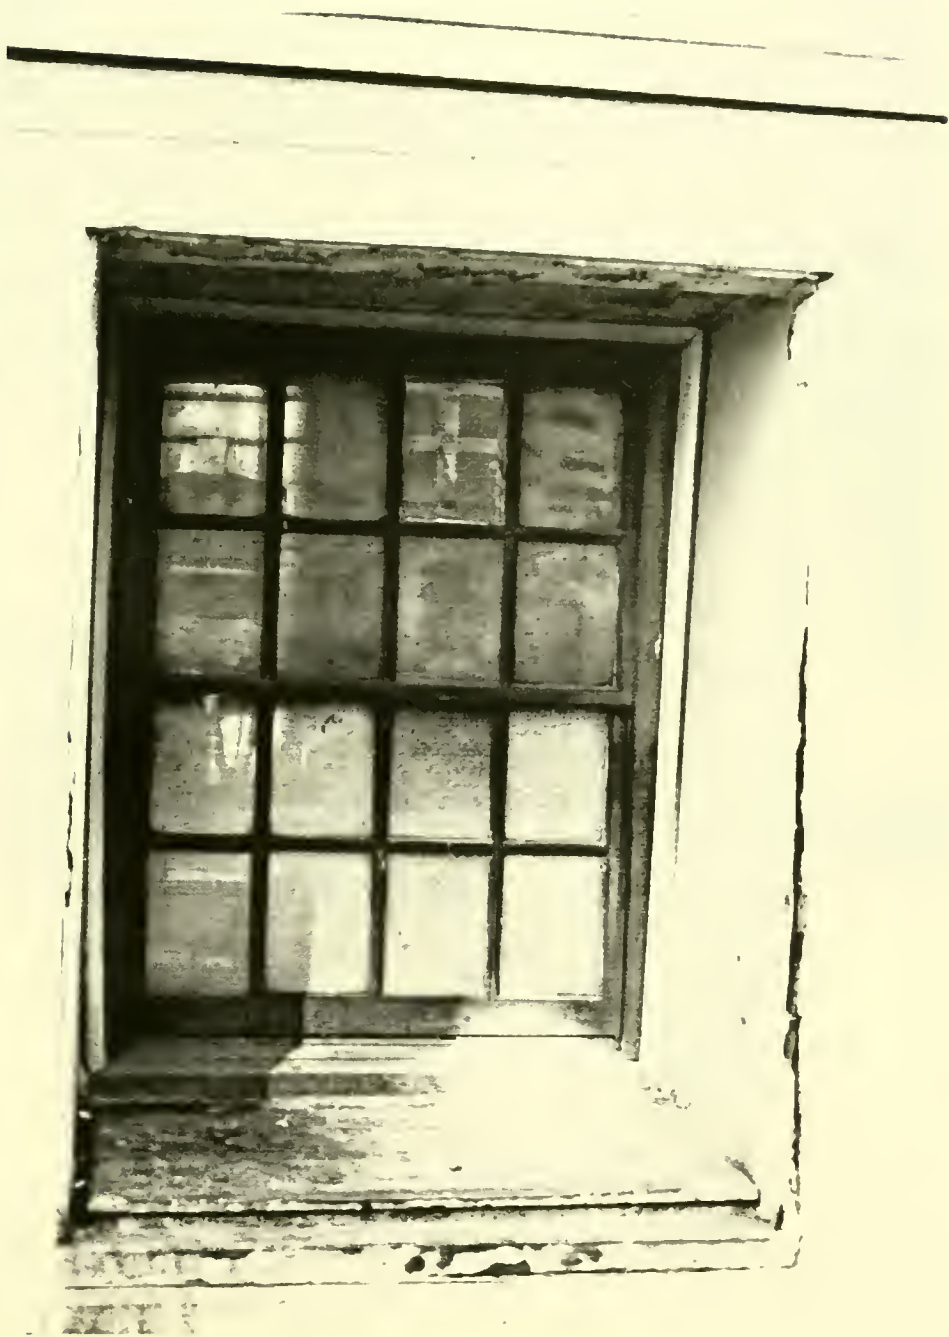
Figure 3

Basement window, East facade.  
Typical conditions

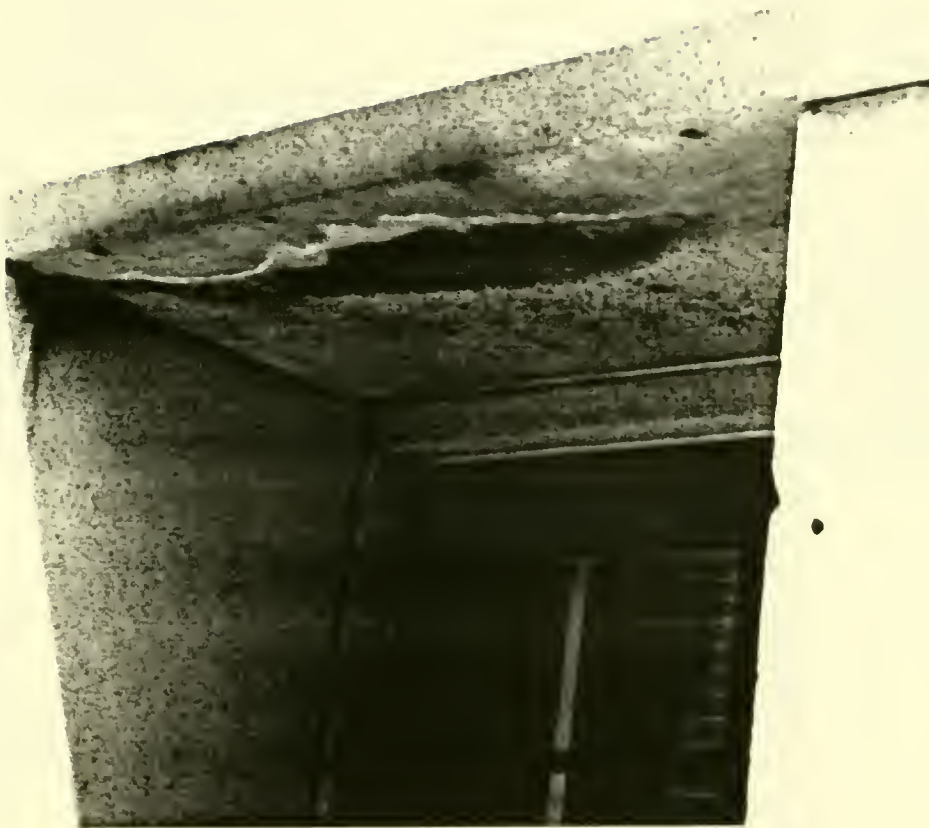
Figure 5

South side, street level  
Typical condition of all window lintels.

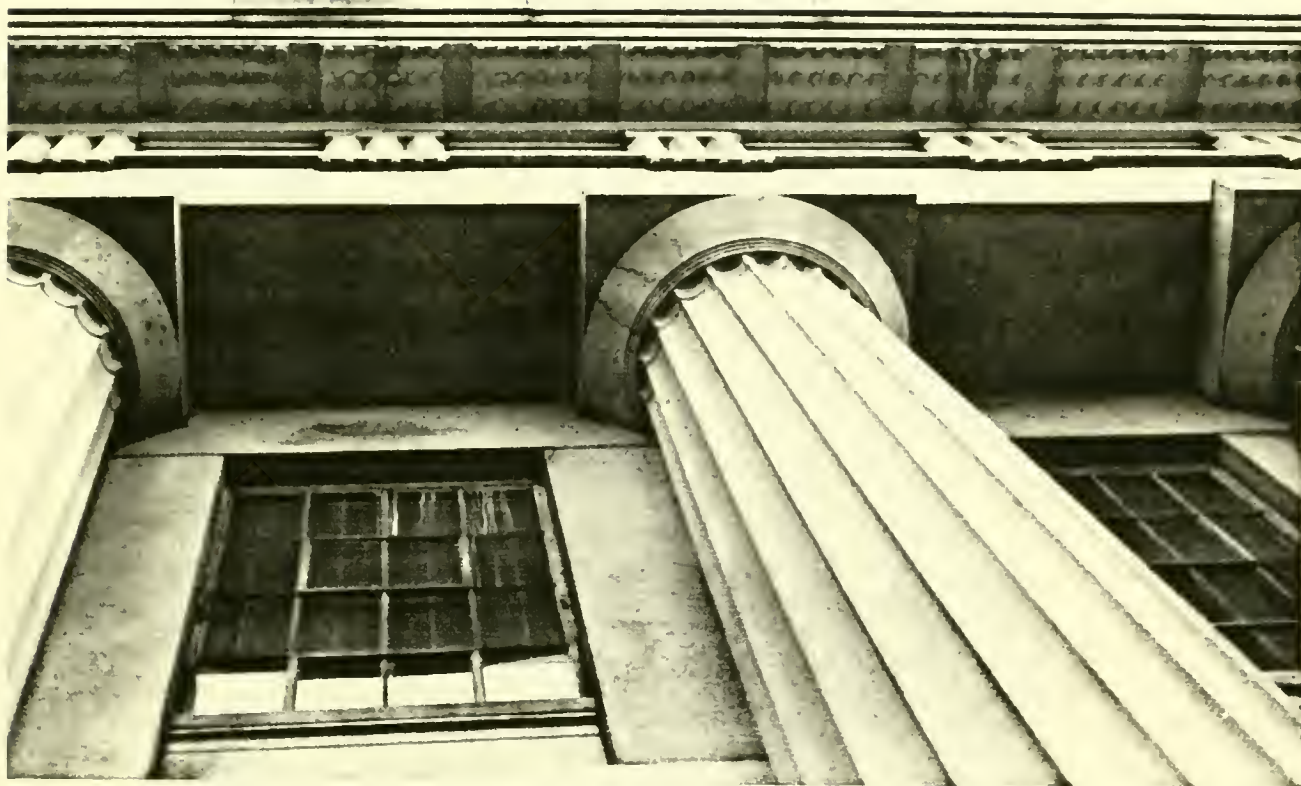
Figure 15

View of water stains in soffit,  
Southern flank, East facade

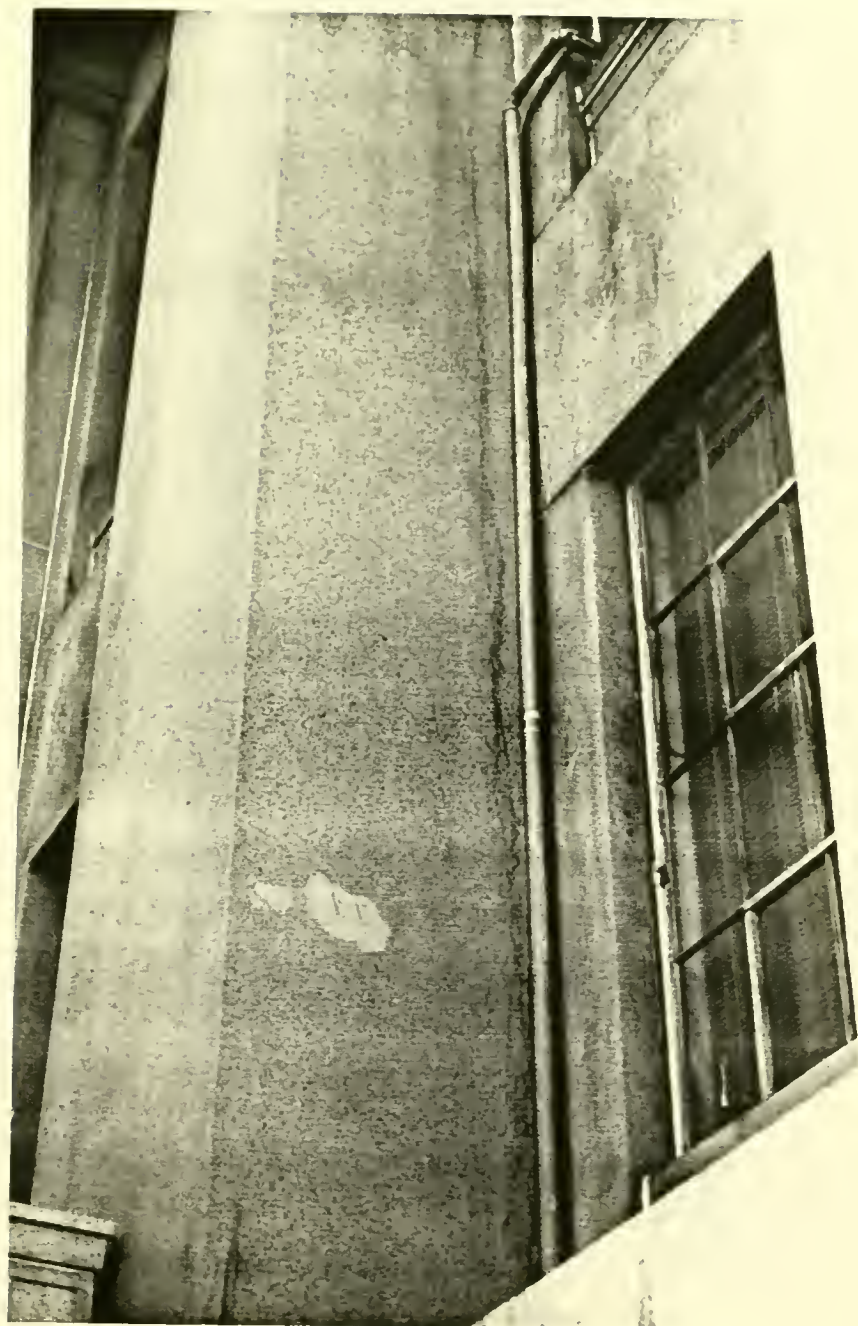
Figure 17

View of water stains, East facade,  
North corner of portico

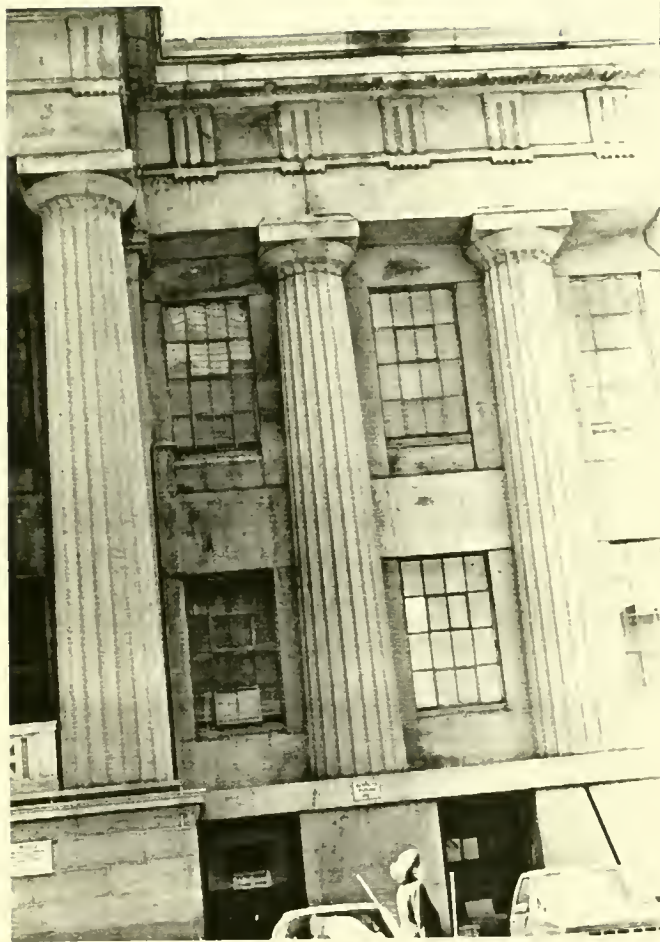
Figure 19

Northern side of East elevation.  
Dark areas correspond with severe  
interior water damage.

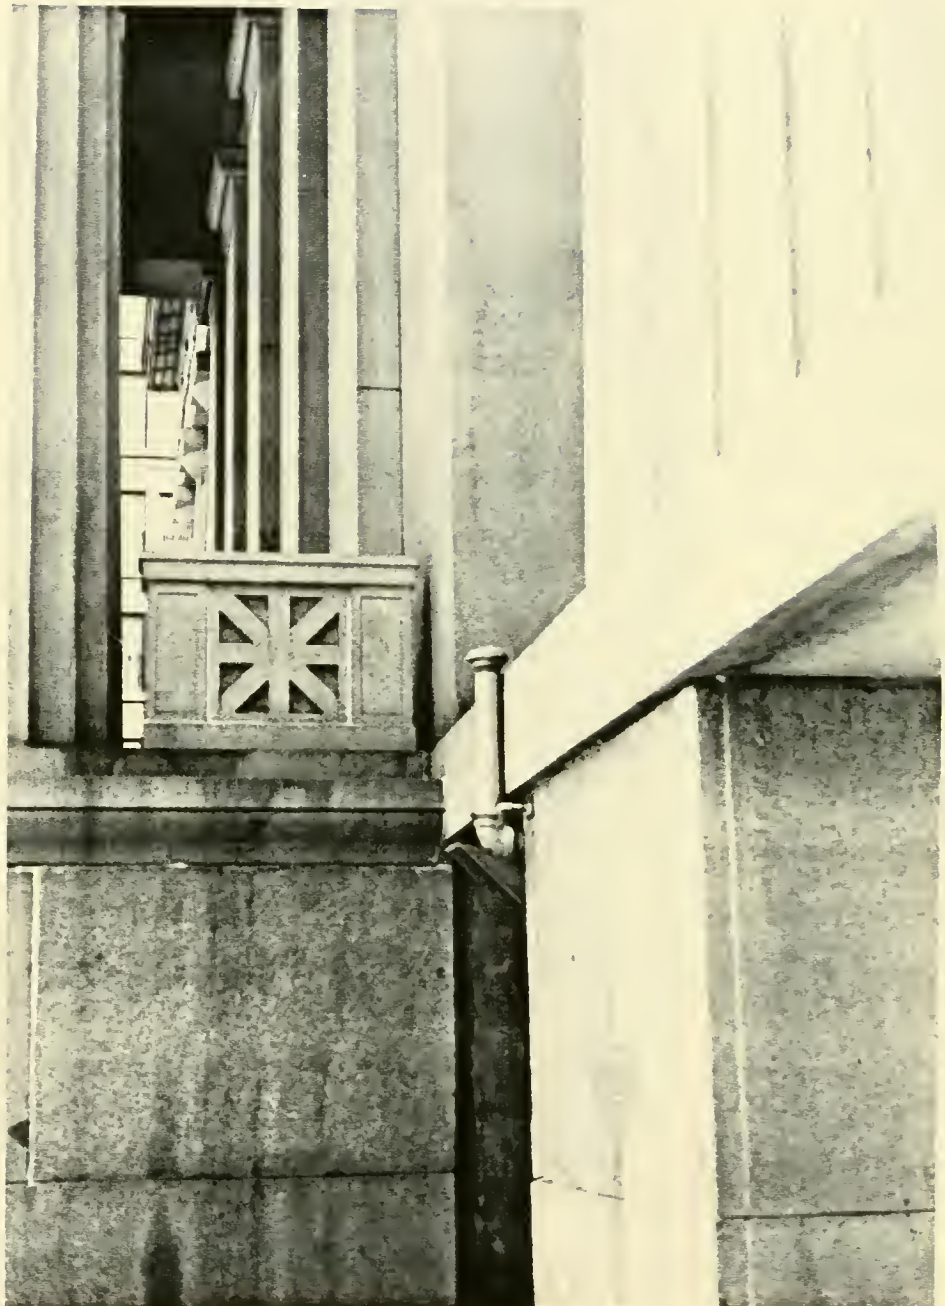
Figure 20

North corner of East portico first floor level  
(dark water stains, poorly located vent)

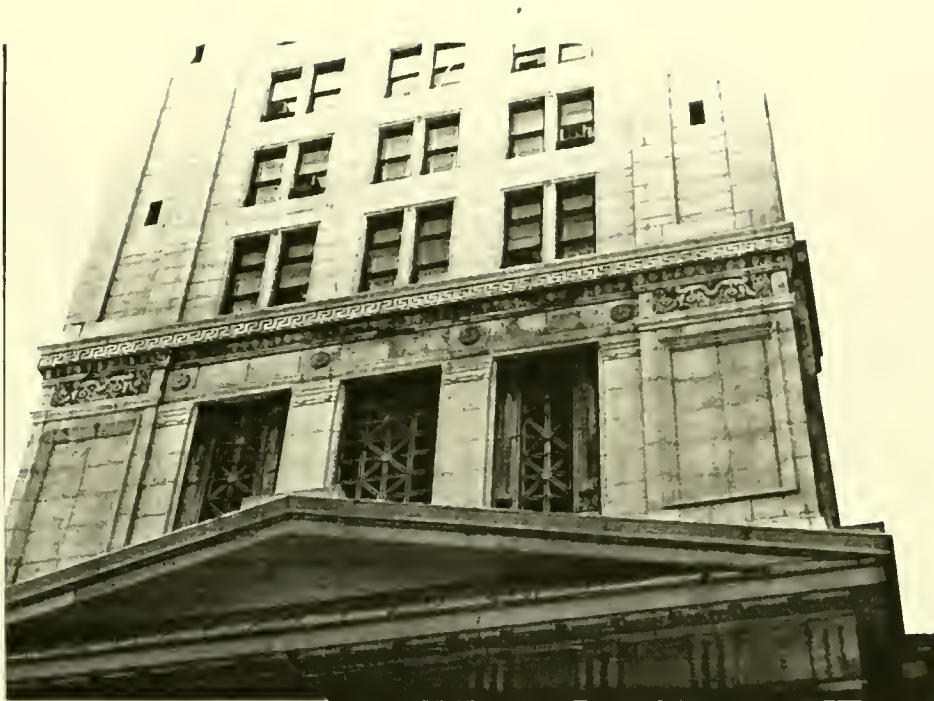
Figure 21

East wall. Dark areas correspond with  
severe interior water damage.

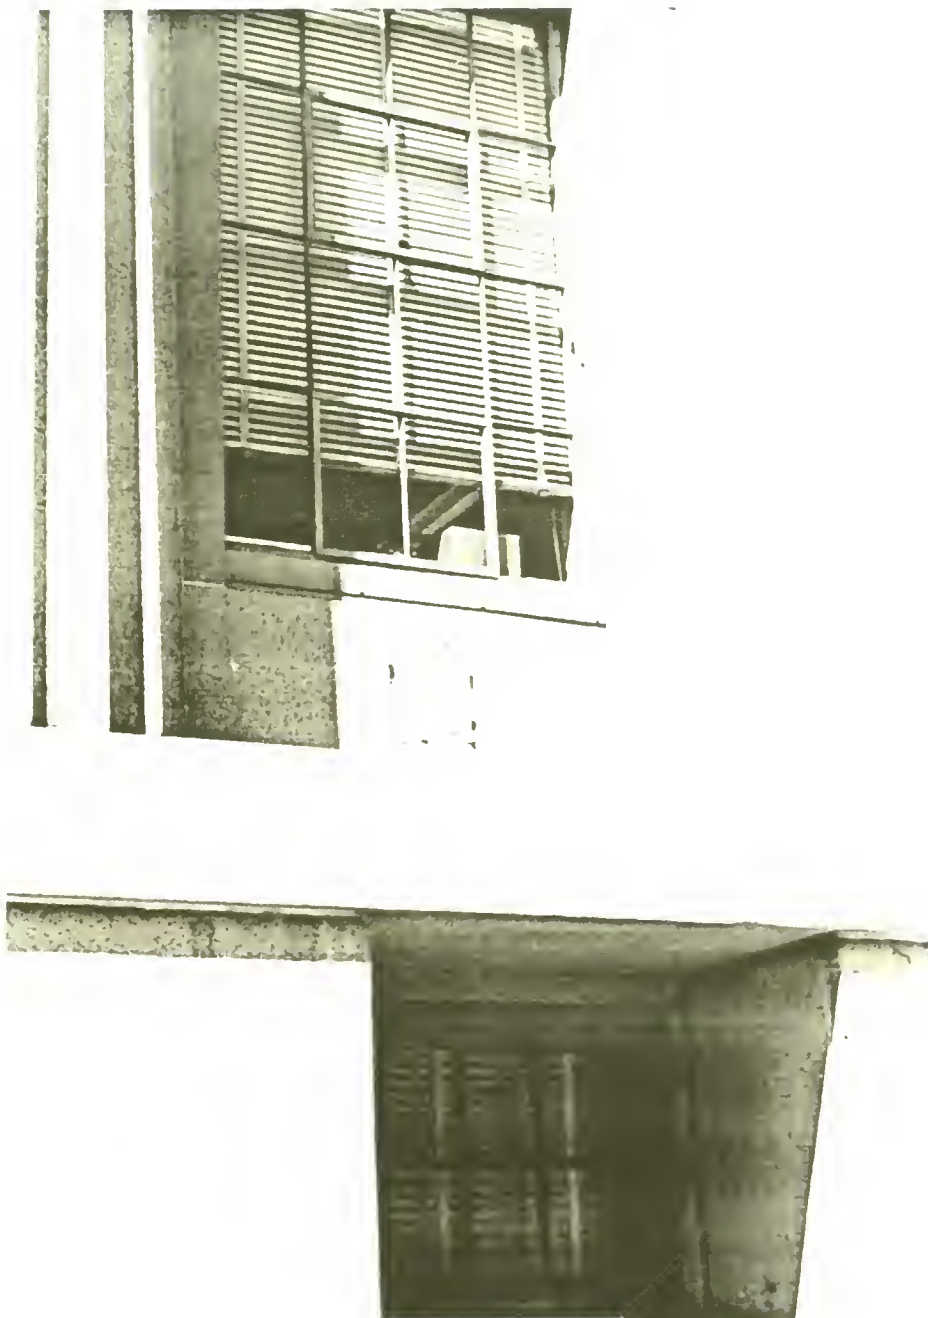
Figure 25

West side, South corner  
Typical remnants of sign adhesive

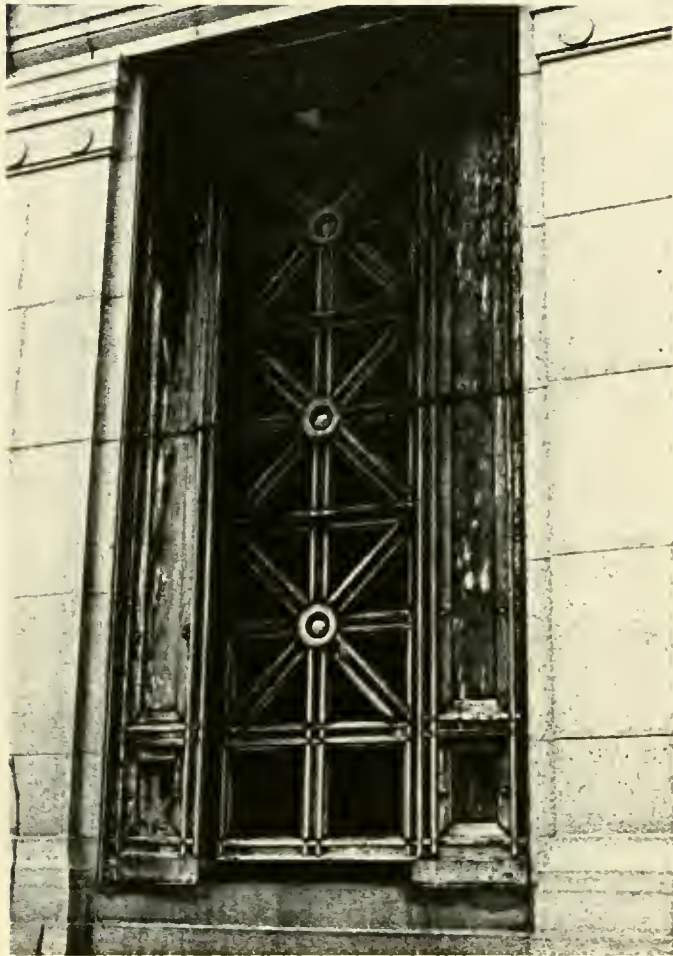
Figure 36

Typical condition of copper grille,  
North side of tower

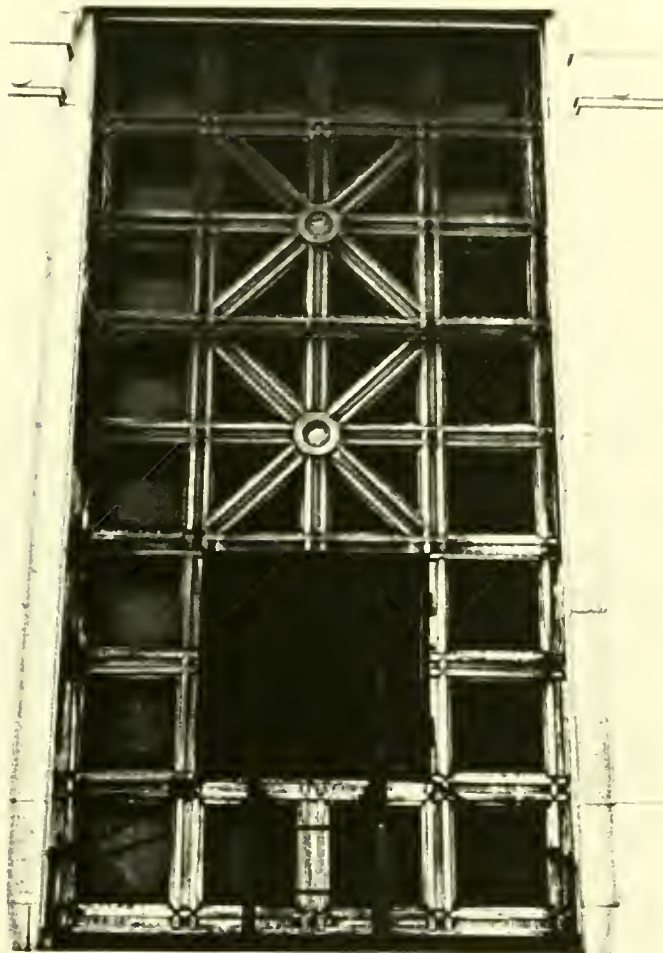
Figure 37

Hinged portion of copper grille missing  
North wall, dome area

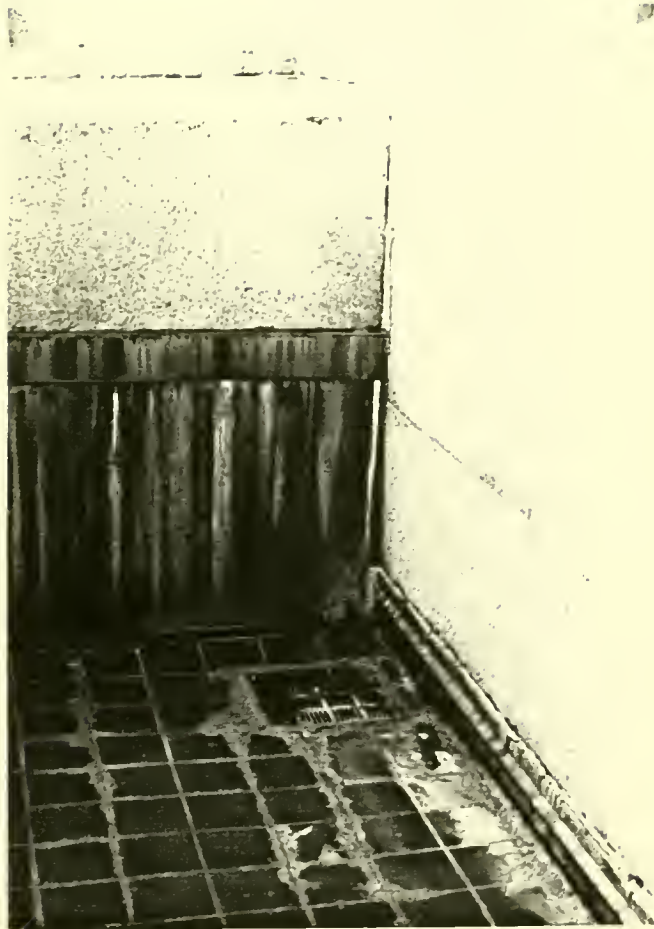
Figure 47

The faults of the drainage system on the Peabody and Stearns Tower portion of the building are also fairly easy to read. On each side of the tower at the 25th floor, two six-inch drain holes exist in the tile floor of each outside balcony. The pitch of these floors is good and water does run toward the holes which connect with interior downspouts as shown on the drawings. However, the water soon collects on the floors of the balconies, especially the east balcony, and runs over the outer edges. Again, on a rainy day, one can see the water stains running down the north corner of the east wall of the Tower most clearly. Similar water flow can be seen at the east corner of the south side as well.

Drain in tile floor, Southeast corner of  
East balcony, Floor 20. Clogged?

One of the most important steps to bring the Custom House and Tower to sound condition, then, is to make the drainage systems fully operable. New design may be necessary if the existing materials (interior leaders and the like) are deteriorated beyond rehabilitation.

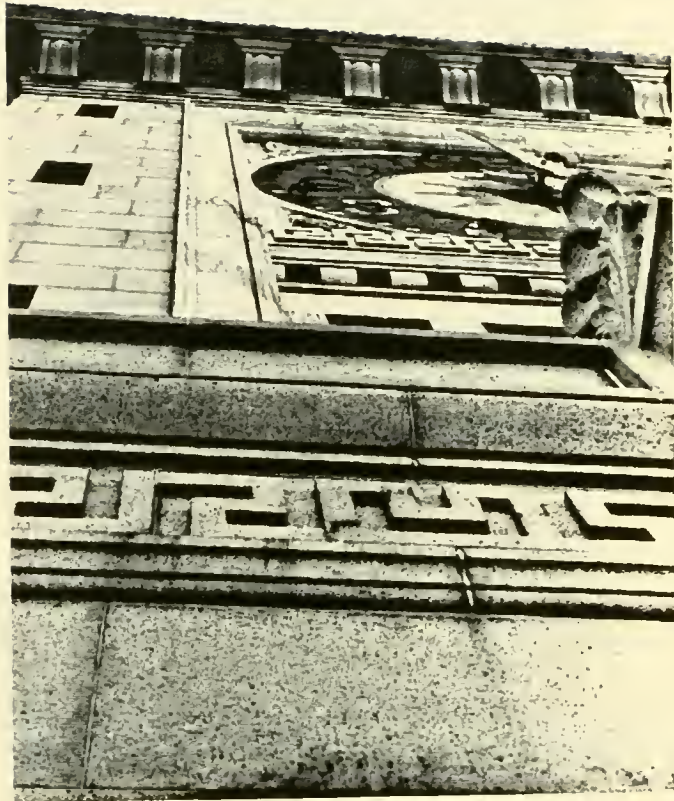
Figure 52

The exterior marble around the great clock face is also in reasonably good condition, but would benefit from careful cleaning. The iron cramps which hold the clock face stone work are rusting and causing stains. In the few areas in need of repointing on the marble, a high-lime mortar should be used and should match the marble so that joint lines do not read as a different color.

Clock face seen from West balcony, Floor 20  
(Signs of dampness at joints)

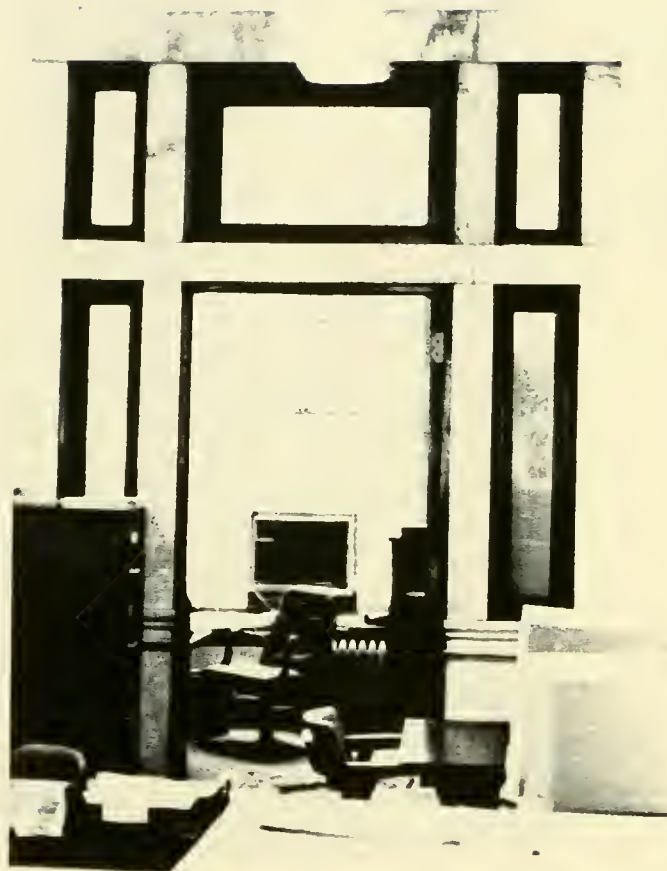
30 - View into office on west side of Auditor's Office showing typical frosted glass, grained metal frames, and marble surrounds, used in the more important offices.

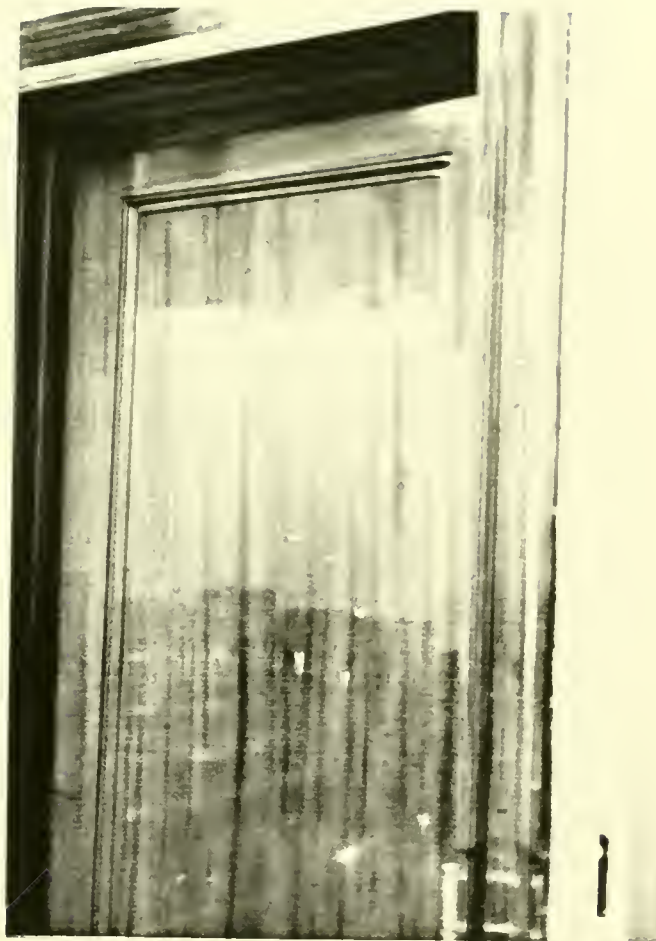
31 - View of more cleaning problems on grained metalwork.

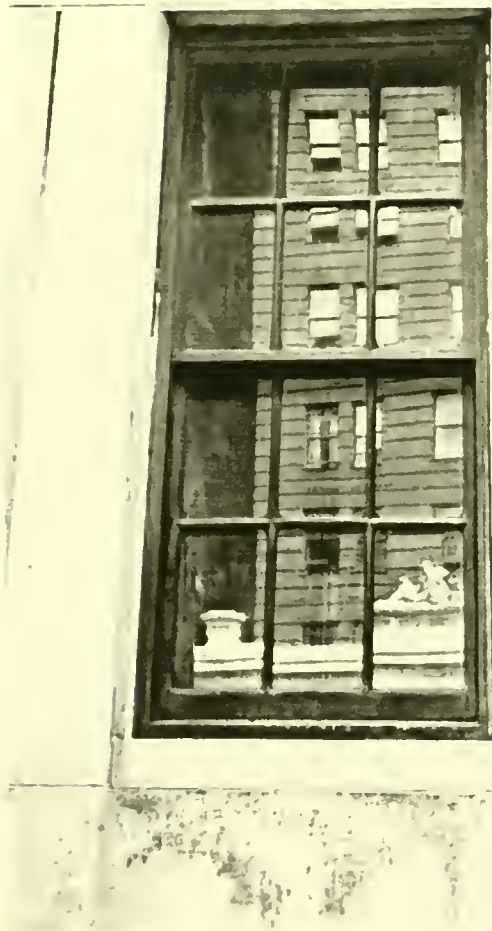
7 - Window to the north of west entry, main floor,  
showing uneven stains and some black caulk.

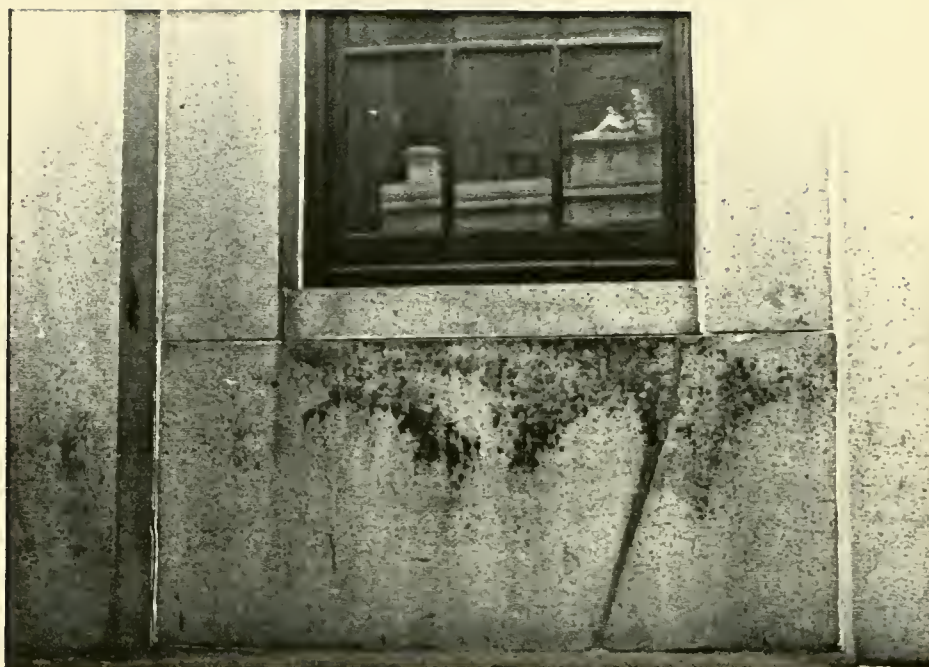
8 - Detail of window in Figure 7.

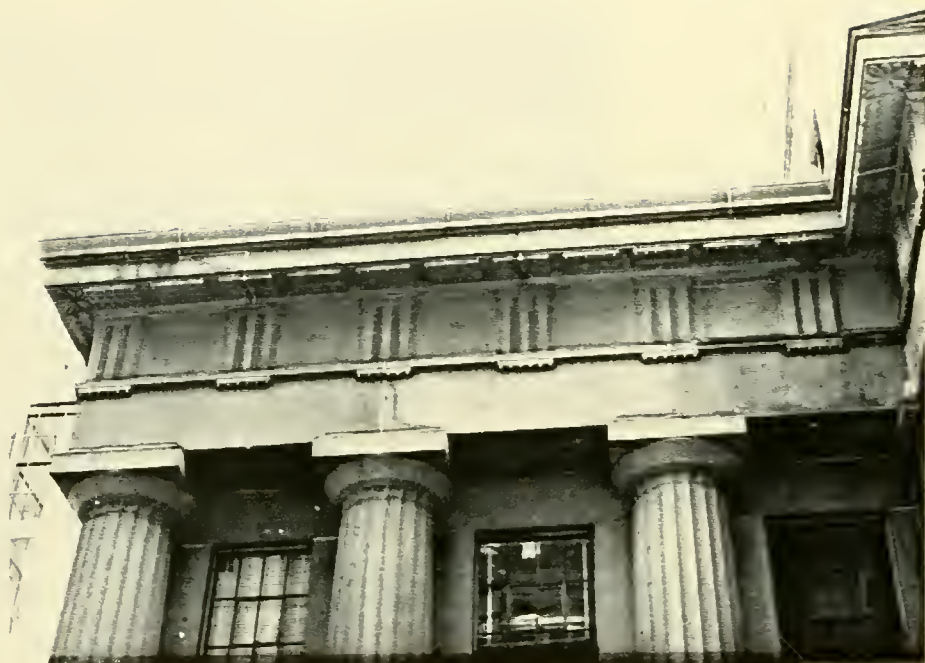
10 - View of architrave, frieze and cornice of northern side of west elevation, showing some water stains.

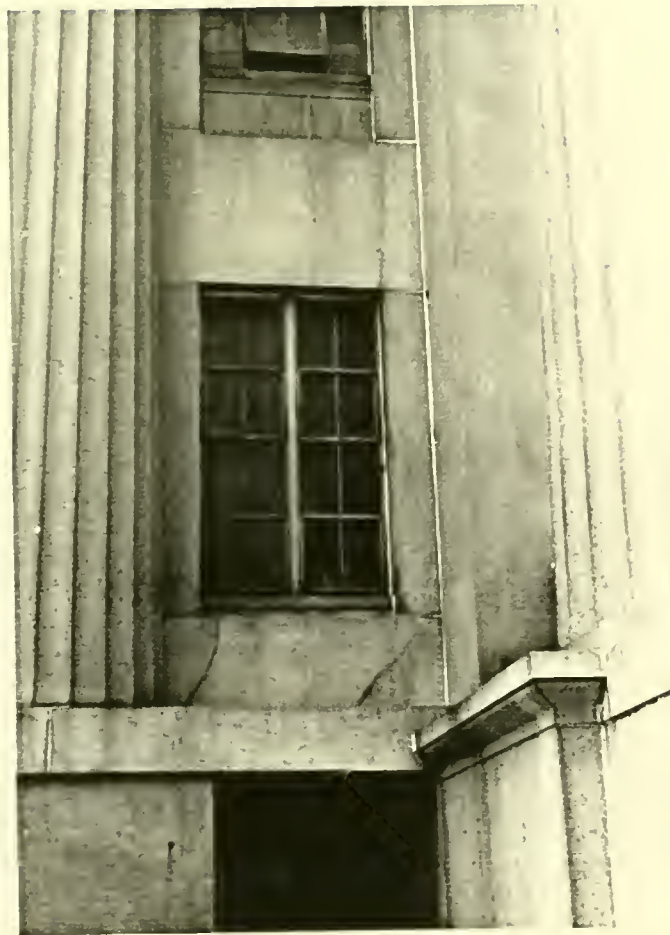
11 - View of 1949 windows and cracked grainte block on northern side of West elevation.

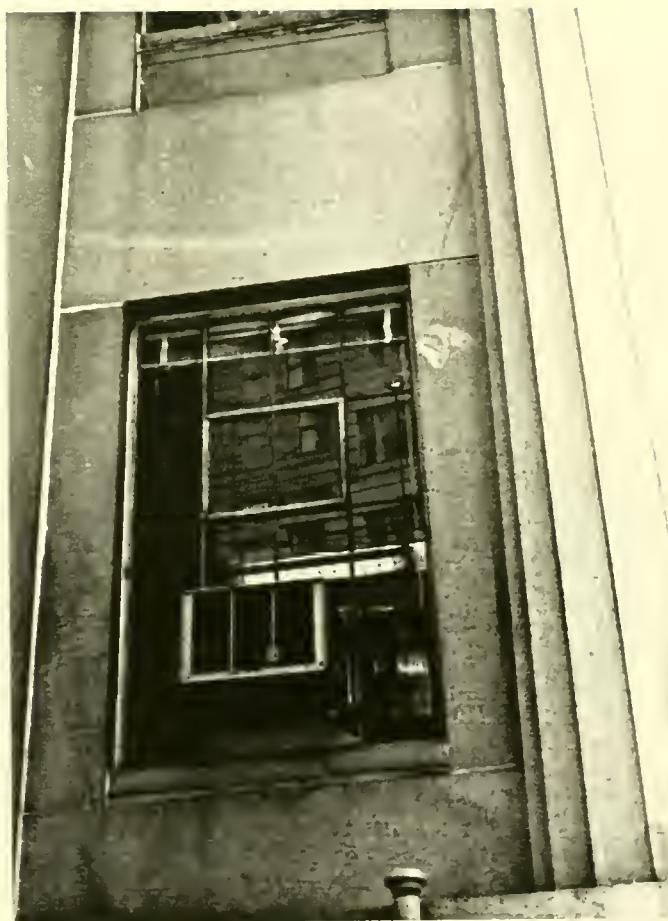
13 - View of 1949 office window, principal floor, to south of west entry, showing white caulk, vent stack and air conditioner (typical).

8. Elevator fronts and cabs could be rehabilitated, using Peabody & Stearns design for new materials.
9. Clean and restore all existing sash which are operable. (Inventory all sash.) Install any new elements such as storm sash from interior. Remove all window air conditioners.

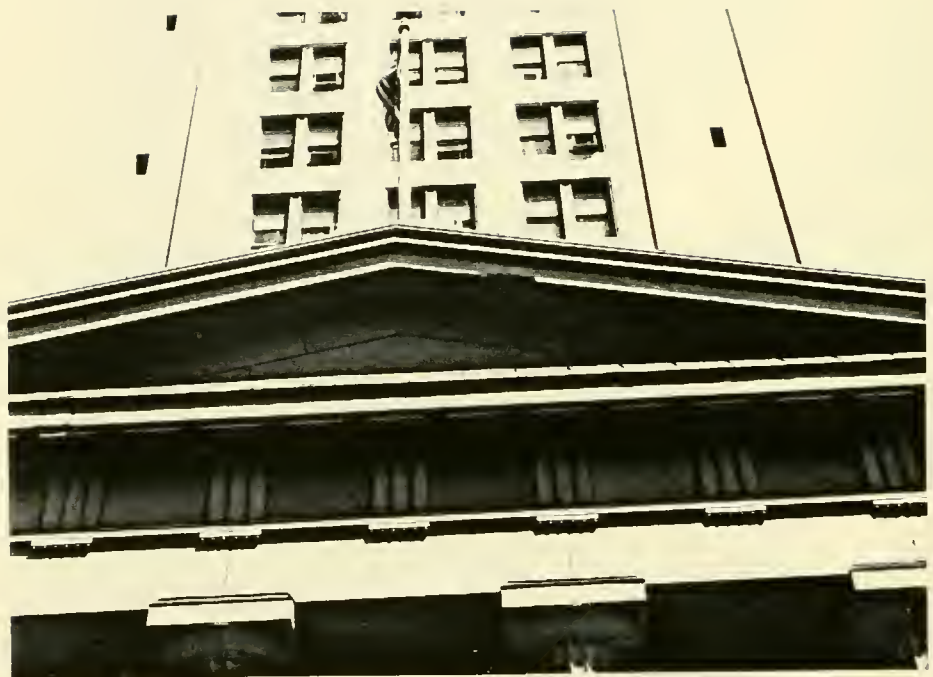
14 - South portico pediment, showing one small section of missing stone.

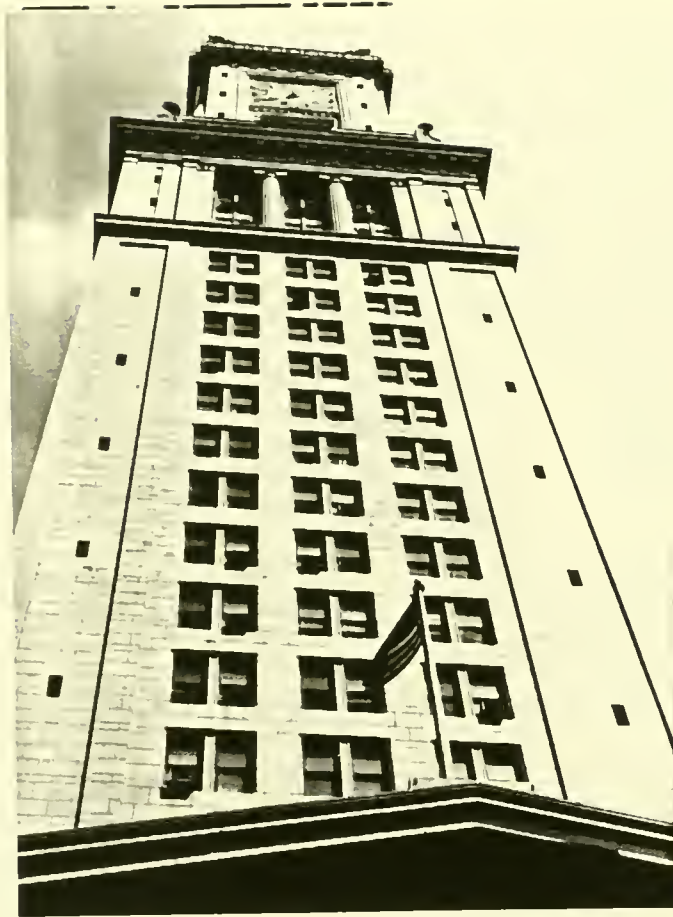
15 - South elevation of Tower, showing dark mortar,  
lighter replacement corner blocks.

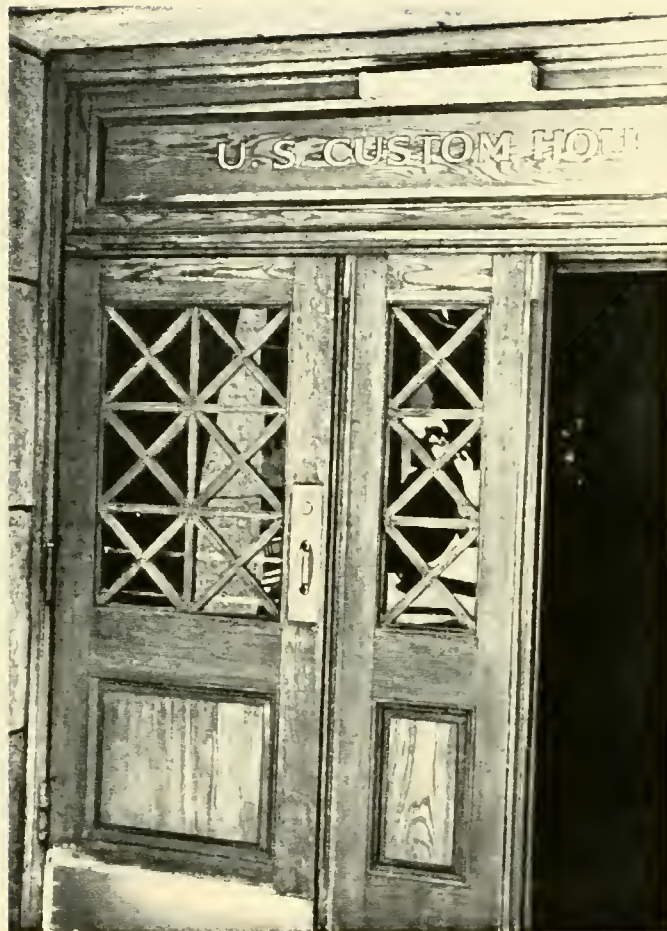
16 - Doorway to ground floor, south entrance, Peabody and Stearns (except for light fixture). Brass polish has damaged wood; wood needs refinishing.

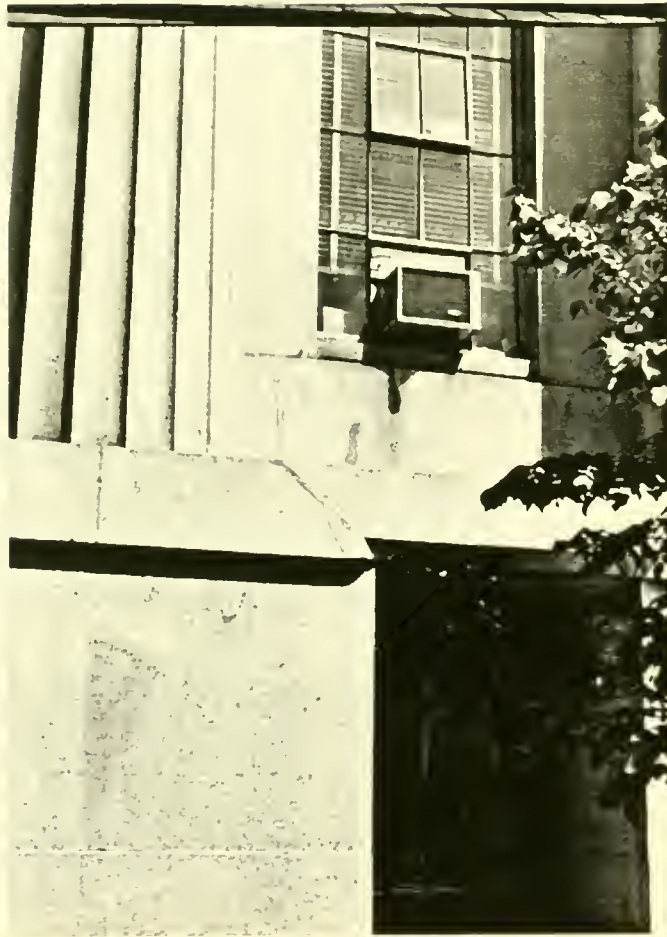
17 - Window to the east of south entrance, ground floor;  
typical conditions.

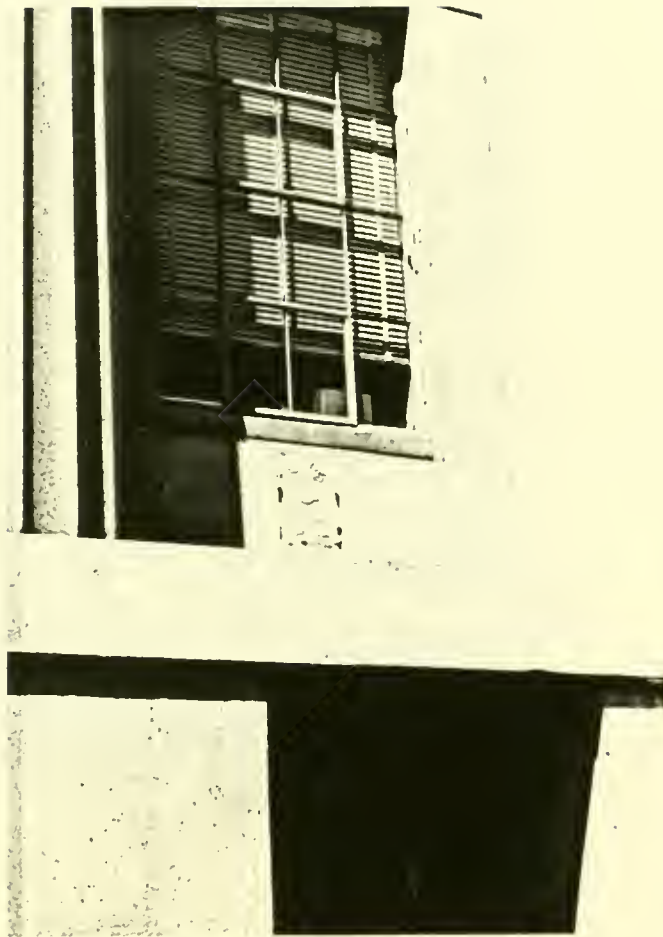
19 - South elevation, typical 1949 window, old mortar from sign, to be removed.

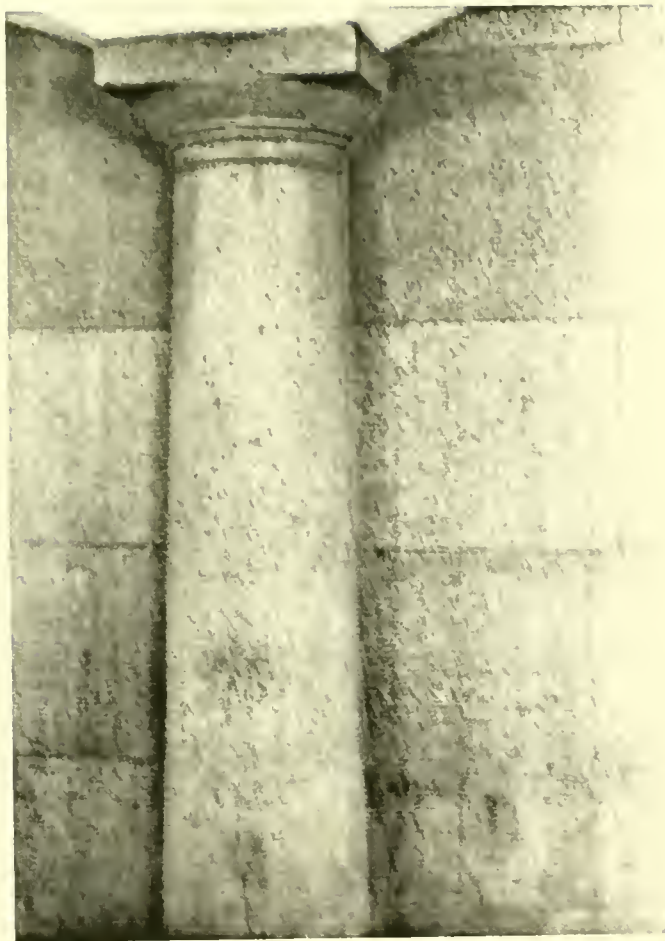
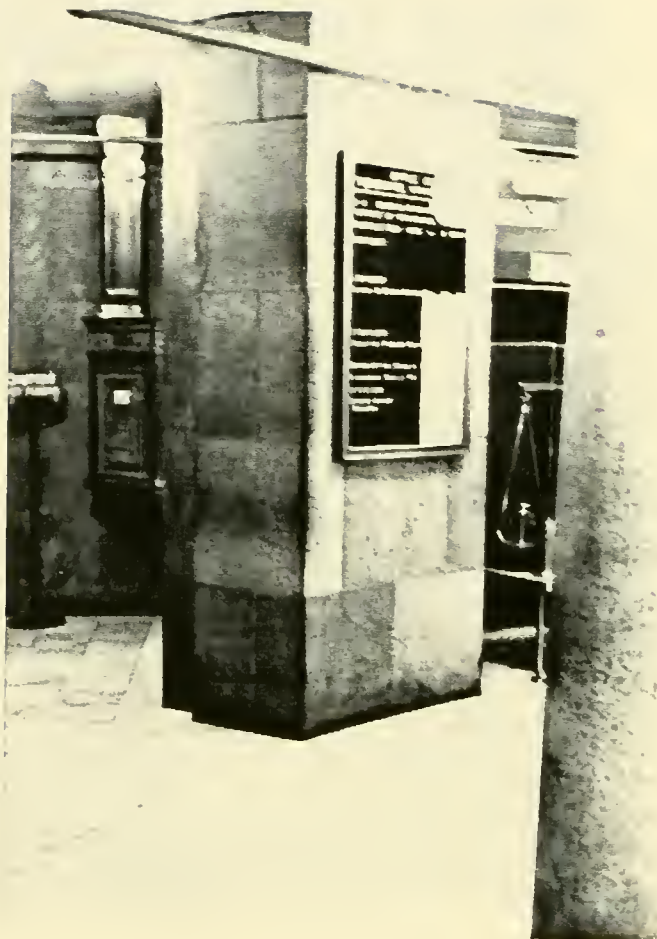
While this granite is free from cracks or spalling, it is stained and dirty. Passing hands have left oil which has become blackened; floor waxes have splashed up on the granite some two to four inches and also have blackened. Most of the pointing is of a fine grapevine profile with a grey mortar which matches the granite, but the few areas of repointing are clumsy.

22 - Views of Young's granite columns and walls on the basement floor (street level), showing typical conditions: oily and black stains from hands at about three to four feet from the floor; blackened areas at the base from floor waxes.

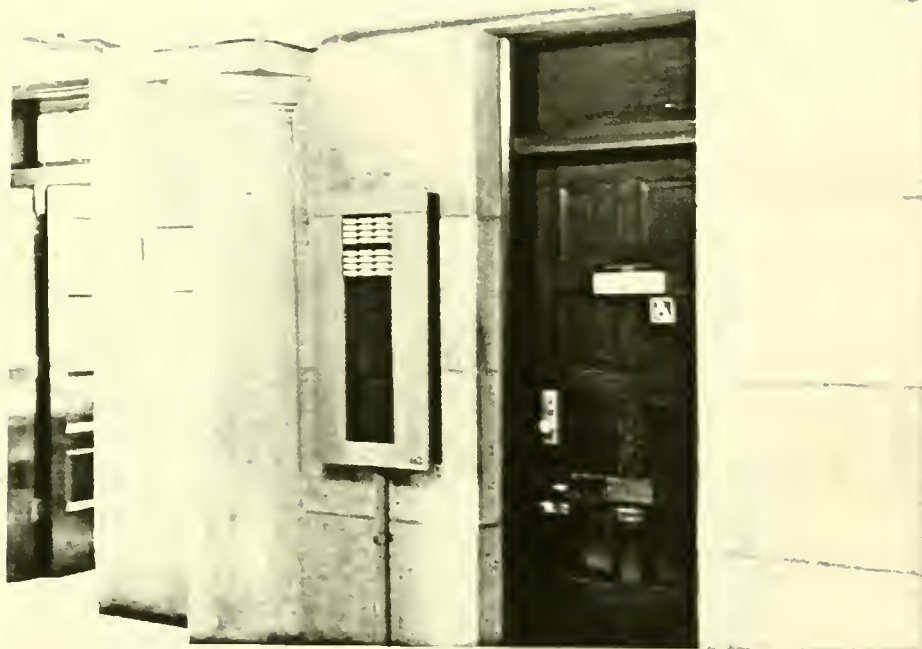
23 - View on the basement floor showing typical placement of signs on the walls, metal door (Peabody and Stearns) painted with wood graining, typical of those throughout the building.
